DEPARTMENT OF TRANSPORTATION

Quality Assurance and Source Inspection

Contract #: 04-0120F4Cty: SF/ALA Rte: 80 PM: 13.2/13.9File #: 69.28**WELDING INSPECTION REPORT****Resident Engineer:**Pursell, Gary**Address:** 333 Burma Road**City:** Oakland, CA 94607**Report No:** WIR-015522**Date Inspected:** 27-Jun-2010**Project Name:** SAS Superstructure**OSM Arrival Time:** 700**Prime Contractor:** American Bridge/Fluor Enterprises, a JV**OSM Departure Time:** 1900**Contractor:** Zhenhua Port Machinery Company, Ltd (ZPMC), Changxing Island **Location:** Shanghai, China**CWI Name:** ZPMC and ABF**CWI Present:** Yes No**Inspected CWI report:** Yes No N/A**Rod Oven in Use:** Yes No N/A**Electrode to specification:** Yes No N/A**Weld Procedures Followed:** Yes No N/A**Qualified Welders:** Yes No N/A**Verified Joint Fit-up:** Yes No N/A**Approved Drawings:** Yes No N/A**Approved WPS:** Yes No N/A**Delayed / Cancelled:** Yes No N/A**Bridge No:** 34-0006**Component:** OBG**Summary of Items Observed:**

WELDING INSPECTION REPORT

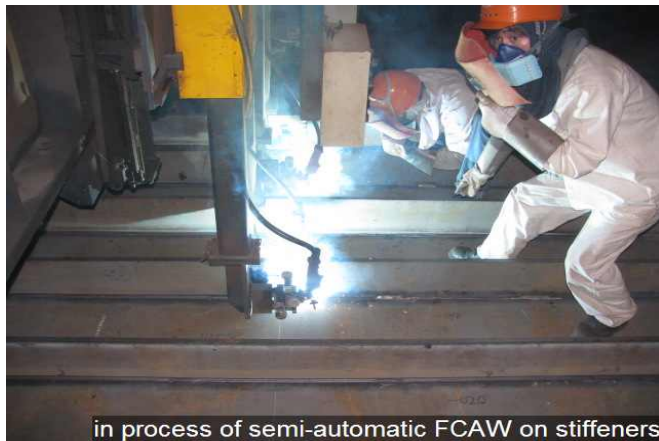
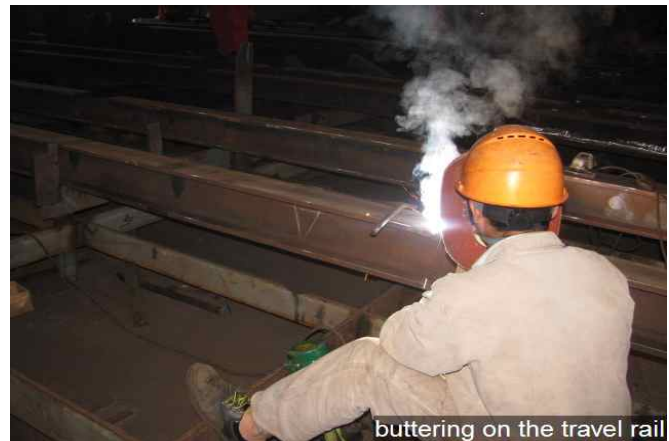
Travel rail beam: -Caltrans QA inspector observed a ZPMC welder performed SMAW build up weld metal (buttering) process on the flange of traveler rail #11TR1-016. The buttering areas are located both ends of top and bottom flanges. The buttering size is along the both edge ends of flanges with 10mm width. All of buttering areas have been pre-heating to specific desired temperature prior SMAW welding. The SMAW process were monitored and recorded by ZPMC and ABF QC inspector. Based on Caltrans QA Inspector observations, no discrepancies were noted.

Travel rail beam: -Caltrans QAI observed two ZPMC heat straightening operators performed heat straightening with ZPMC Heat Straightening Report on travel rail beams. The travel rail beams ID are 11TR1-016, 11TR3-016, 11TR2-016 and 10TR2-012. The heating temperature is maximum 650 C (1200 F) and cool in still air. All the plates for heat straightening have been inspected and recorded by ZPMC QC. Based on Caltrans QAI observation, no discrepancies were noted.

Caltrans QA Inspector observed two welding operators in process of semi-automatic FCAW on stiffeners. The stiffener weld is designed PJP with T-joint weld and located on the side plate. The side plate and stiffener weld ID is SP3093A/SP3093A-001-030~041. All of PJP joint regions have been pre-heating to specific desired temperature prior welding. The semi-automatic FCAW process was monitored and recorded by ZPMC and ABF QC inspector. Based on Caltrans QAI observations, no discrepancies were noted.

Cross beam: - Caltrans QA inspector observed a ZPMC welder performed FCAW CJP process on the flange to flange for floor beam of cross beam # CB17. The weld ID is FB3058-056-030. The region of the weld joint has been pre-heating to specific desired temperature prior FCAW welding. The FCAW process were monitored and recorded by ZPMC and ABF QC inspector. Based on Caltrans QA Inspector observations, no discrepancies were noted.
